MAINTENANCE ADVISORY

Shock Mount Failures on MEP-903A 10kW Auxiliary Power Units (APUs)

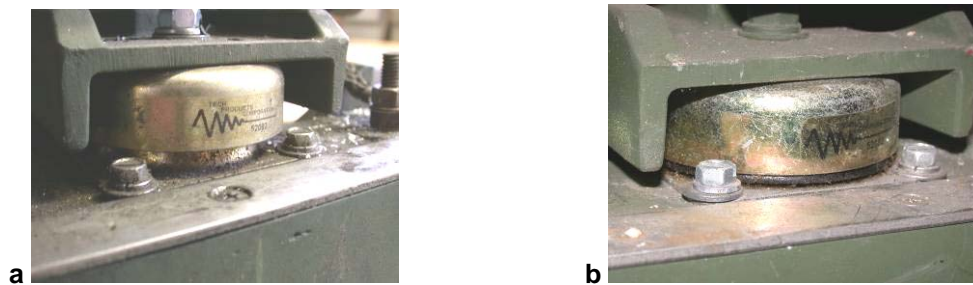
Failures have been repeatedly observed for the shock mounts supporting the engine and alternator on MEP-903A model 10kW APUs. Both new and used APUs have shown the tendency of engine and alternator shock mount failure (collapse). Investigation is currently underway to determine if failure of the shock mounts is also related to an increase in reported APU radiator failures. Without the dampening provided by functioning shock mounts, vibrations during long road trips may be transmitted into the APU frame to its radiator resulting in cracks and leaks. Failed shock mounts may also result in excessive vibration being transmitted into the SICPS shelter.

Requirements for the loaded/compressed height of the mounts have not been defined, but as shown in the figures below, failure is clearly evident upon visual inspection. The observed normal height of the mounts under load is 1.250 inches, measured from the top of the shock mount to the top of the mounting base. In most cases, the failed shock mount is compressed to the extent that its rubber elastomer touches the top of its mounting base.

Figure 1. (a) Functioning shock mount, (b) Failed/collapsed shock mounts

In light of these recurring failures, an initial visual inspection of all 4 shock mounts (both the engine & alternator mounts) should be performed as part of operator PMCS, followed by additional inspections every 100 hours in conjunction with the recommended oil change interval for the 10 kW APU.

If a shock mount is observed to have failed per a visual inspection, units should acquire a replacement mount per the recommended part numbers in the table below. Please note that engine and alternator mounts are different since the mounts have different damping characteristics and were selected for the loading tendencies at their respective locations. **Part numbers corresponding to the engine mounts should not be used as replacements for the alternator mounts and vice versa.**
